# BRAMPTON MATERIALS ENGINEERING

Date: October 2, 2024  
Attention: Project Manager  
125 Euphemia Street South, Sarnia, ON  
Project: Guardrail Load Testing  
Subject: Balcony Guardrails in Suite 404  
Our Reference: 4162-TR-GR

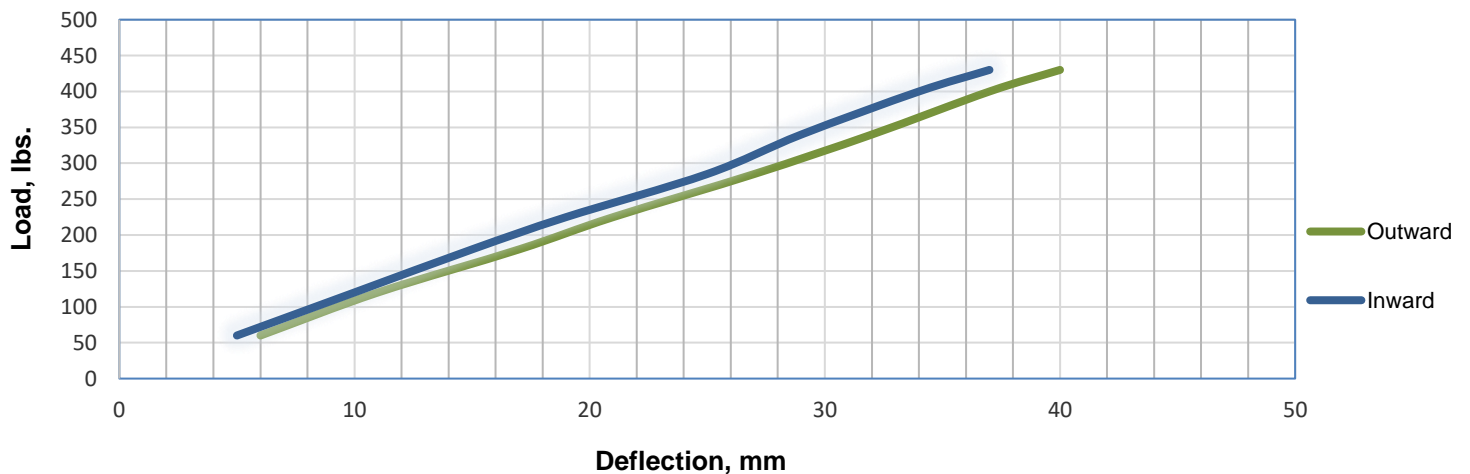
**Table 1A: Summary of Guardrails Load Testing (OBC 2012)**

A horizontal point load of 225 lbs. was applied at the top of an intermediate post (Section L-L in Figure 1a). The load was then increased to 430 lbs. (ultimate load) without failure. The maximum and residual displacements were noted and checked for compliance with the deflection criteria of Sections 2.4 and 2.5.

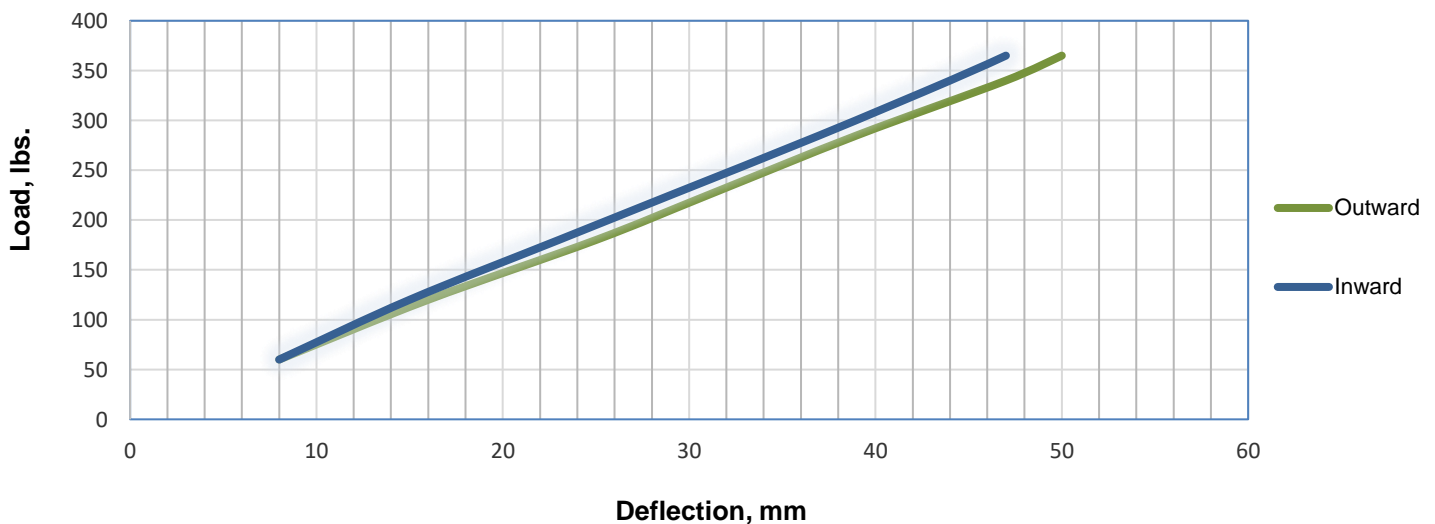
**Table 1B: Summary of Guardrails Load Testing (OBC 2012)**

A horizontal point load of 225 lbs. was applied at the top of an end post (Section K-K in Figure 1a). The load was then increased to 365 lbs. (ultimate load) without failure. The maximum and residual displacements were noted and checked for compliance with the deflection criteria of Sections 2.4 and 2.5.

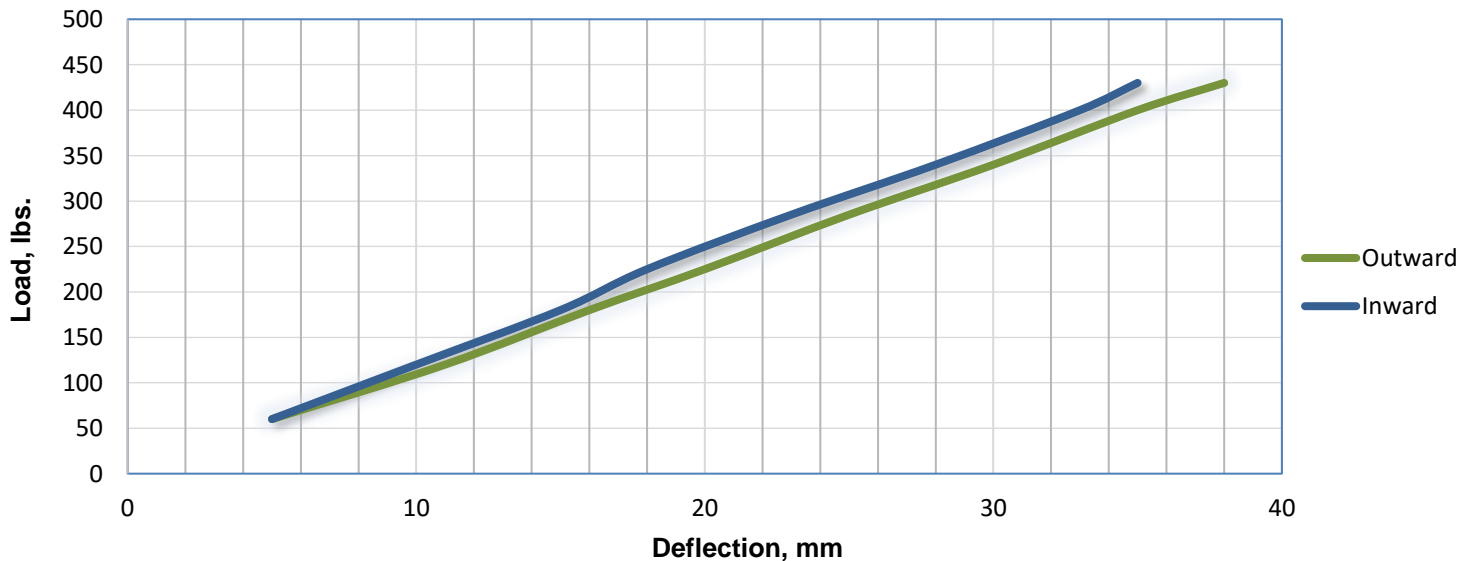
**Table 1C: Summary of Guardrails Load Testing (OBC 2012)**

A horizontal point load of 225 lbs. was applied at the handrail mid-section (Section L-R in Figure 1a). The load was then increased to 430 lbs. (ultimate load) without failure. The maximum and residual displacements were noted and checked for compliance with the deflection criteria of Sections 2.4 and 2.5.

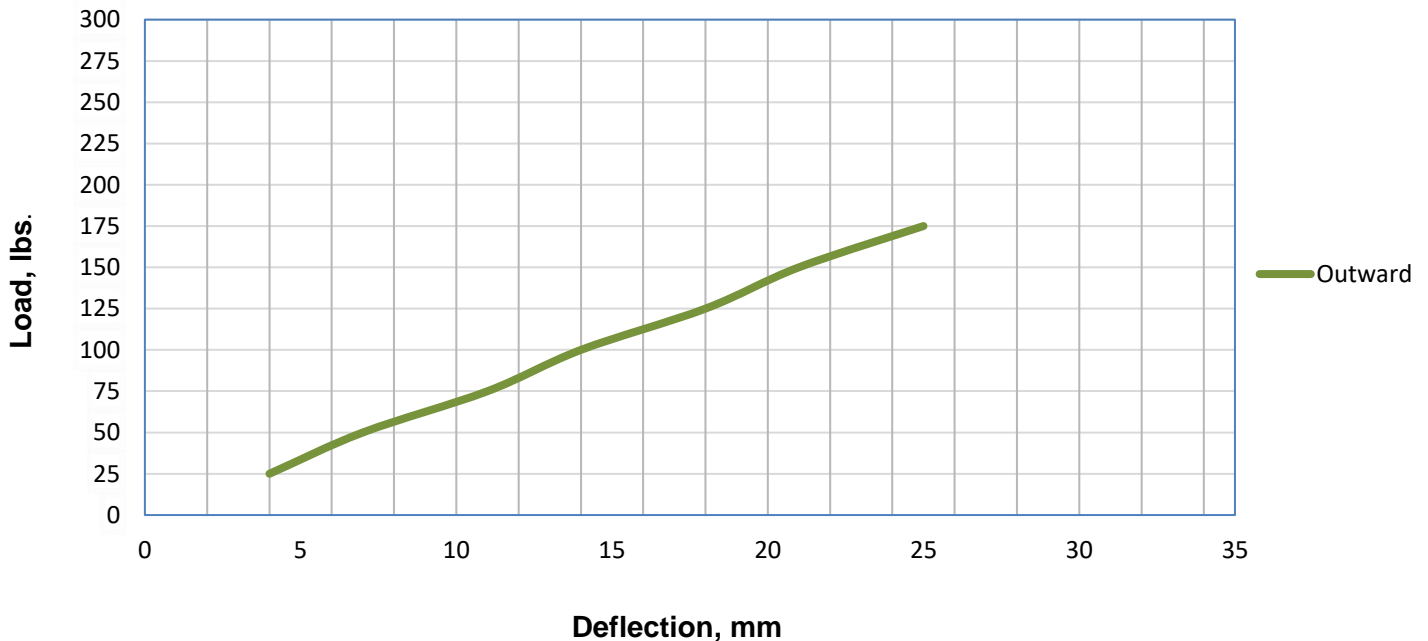
**Table 1D: Summary of Guardrails Load Testing (OBC 2012)**

A horizontal outward load of 115 lbs. was applied at the mid-section of infill picket panel (Section L-R in Figure 1a). The load was then increased to 175 lbs. without failure. The maximum and residual displacements were noted and checked for compliance with the deflection criteria of Sections 2.4 and 2.5.

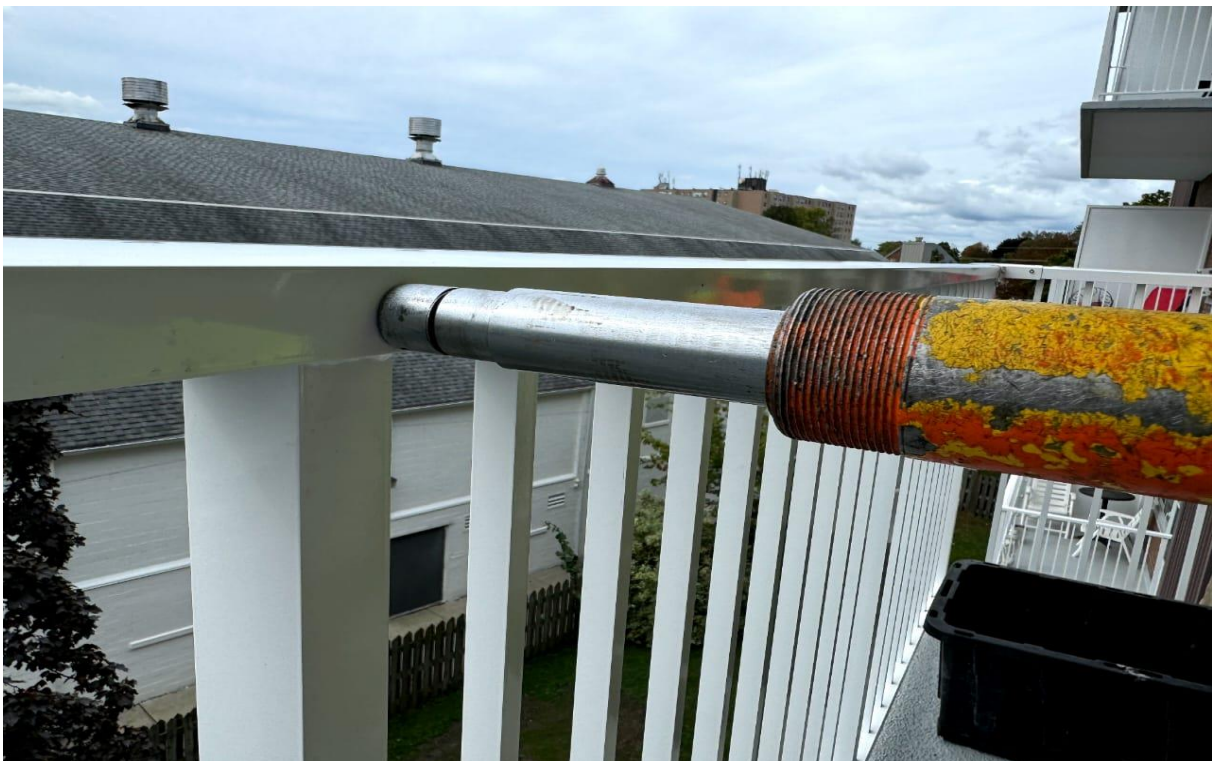
Photograph 4: Showing outward load application at the top of an intermediate post

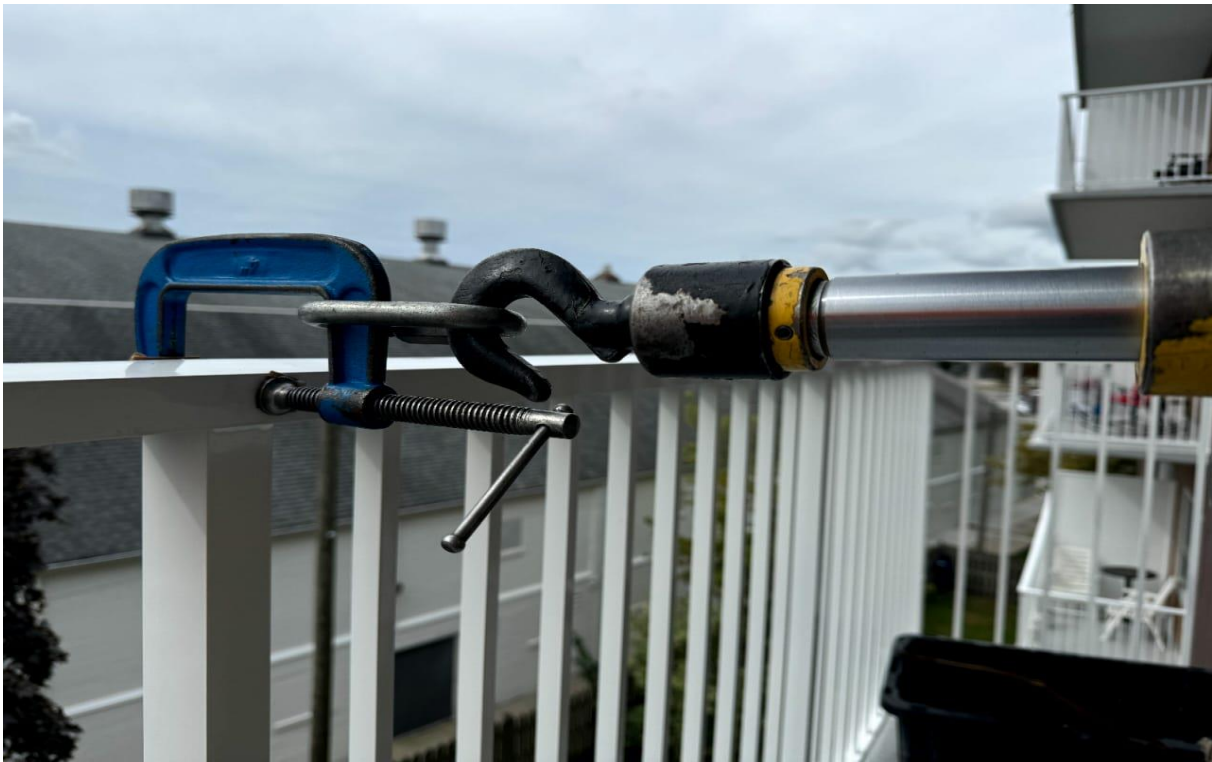
Photograph 5: Showing inward load application at the top of an intermediate post

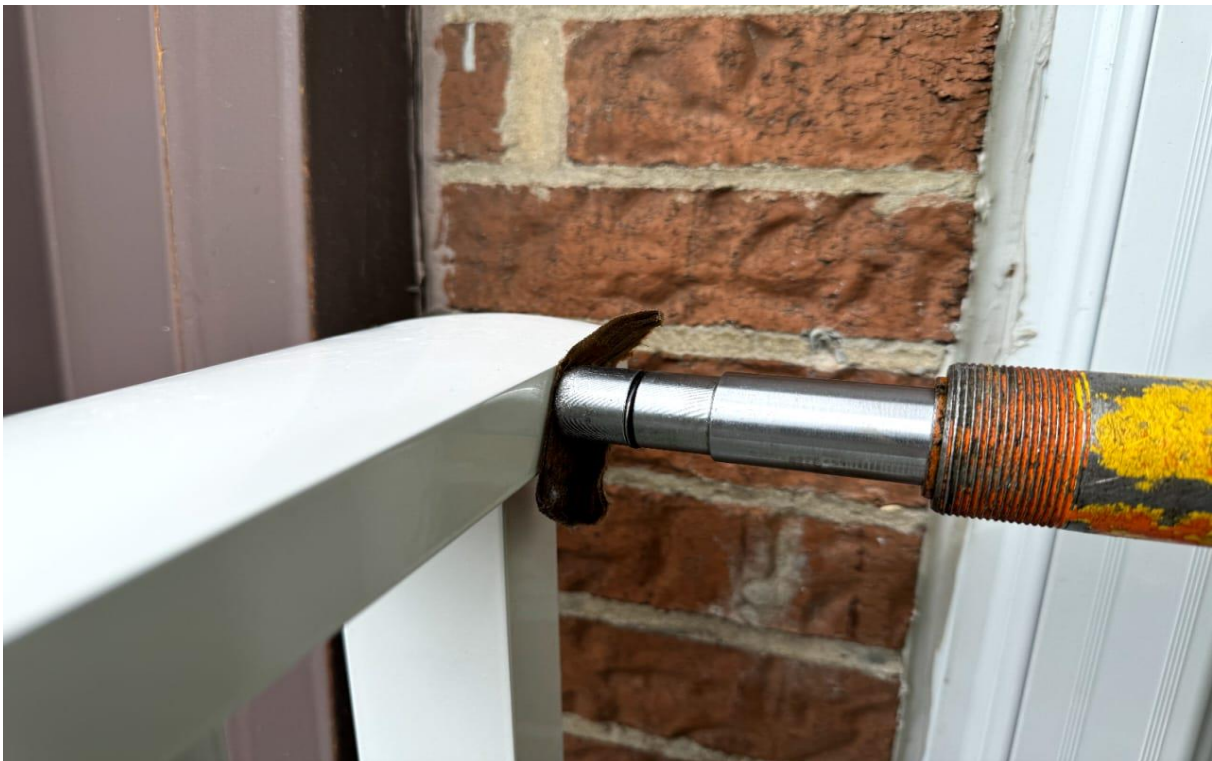
Photograph 6: Showing outward load application at the top of an end-post

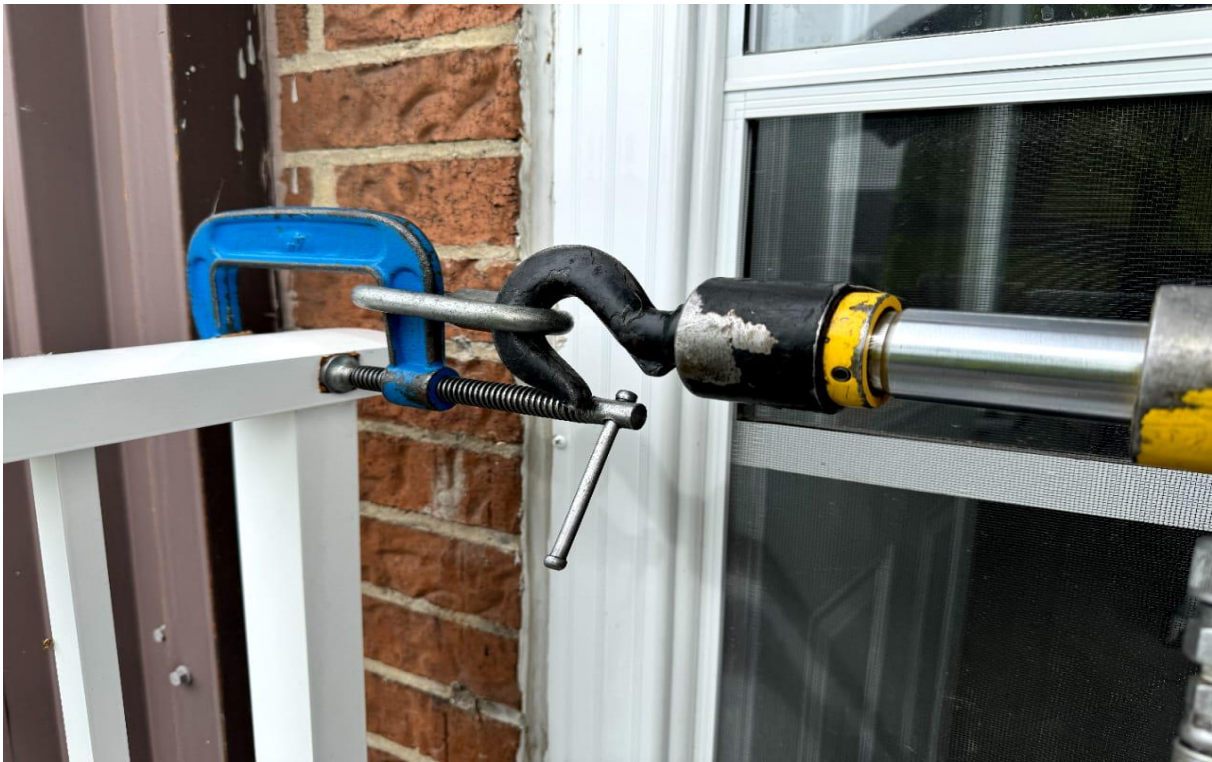
Photograph 7: Showing inward load application at the top of an end-post

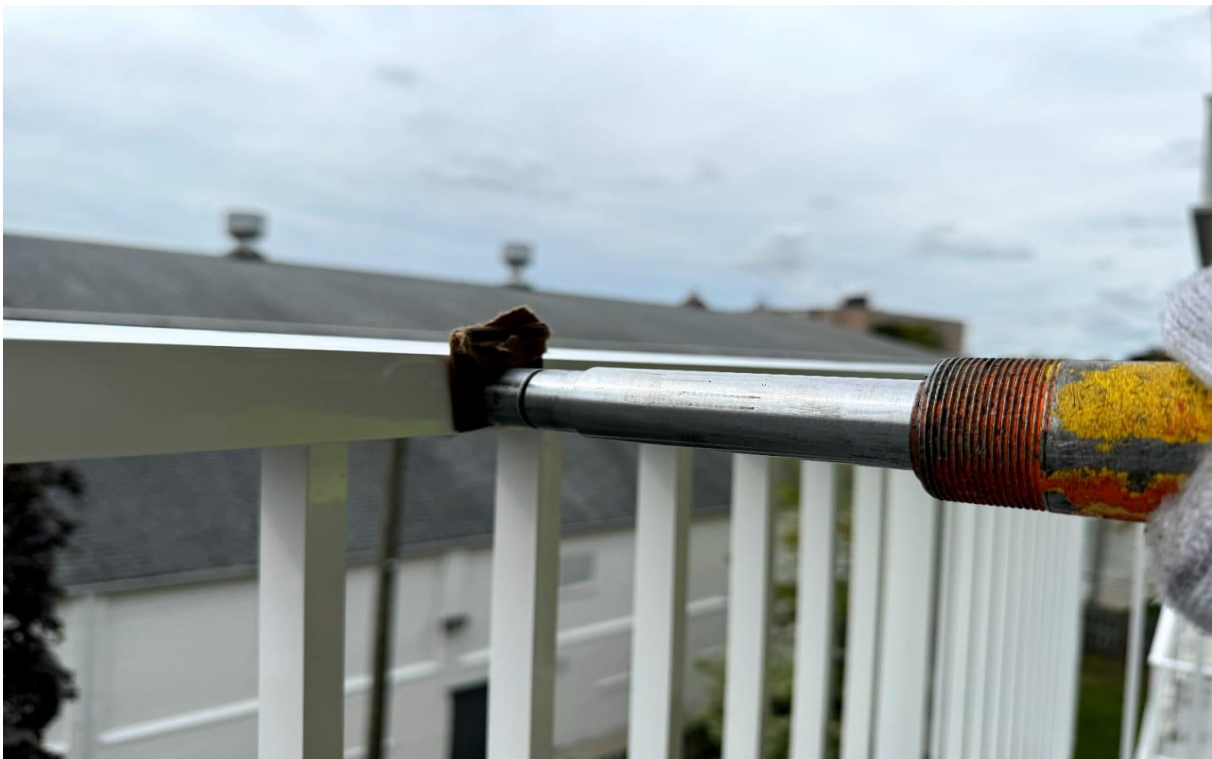
Photograph 8: Showing outward load application at the handrail mid-section

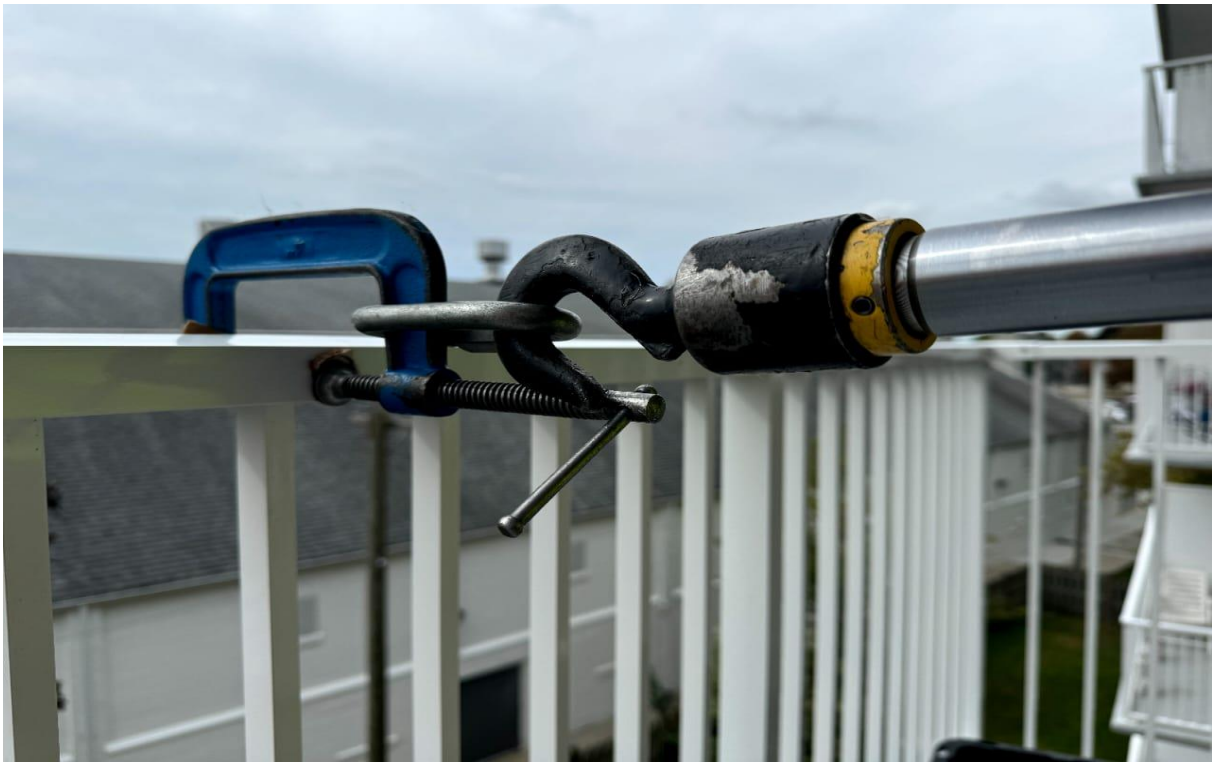
Photograph 9: Showing inward load application at the handrail mid-section

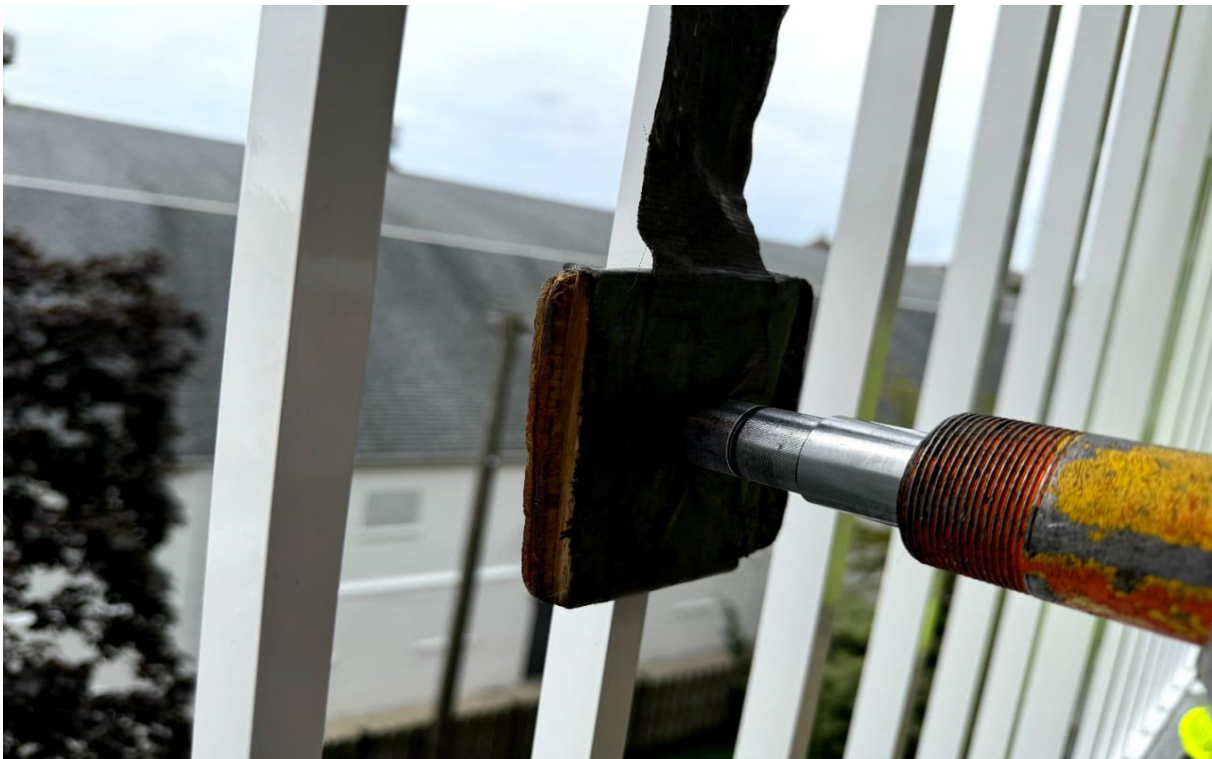
Photograph 10: Showing outward load application at the infill picket panel mid-section

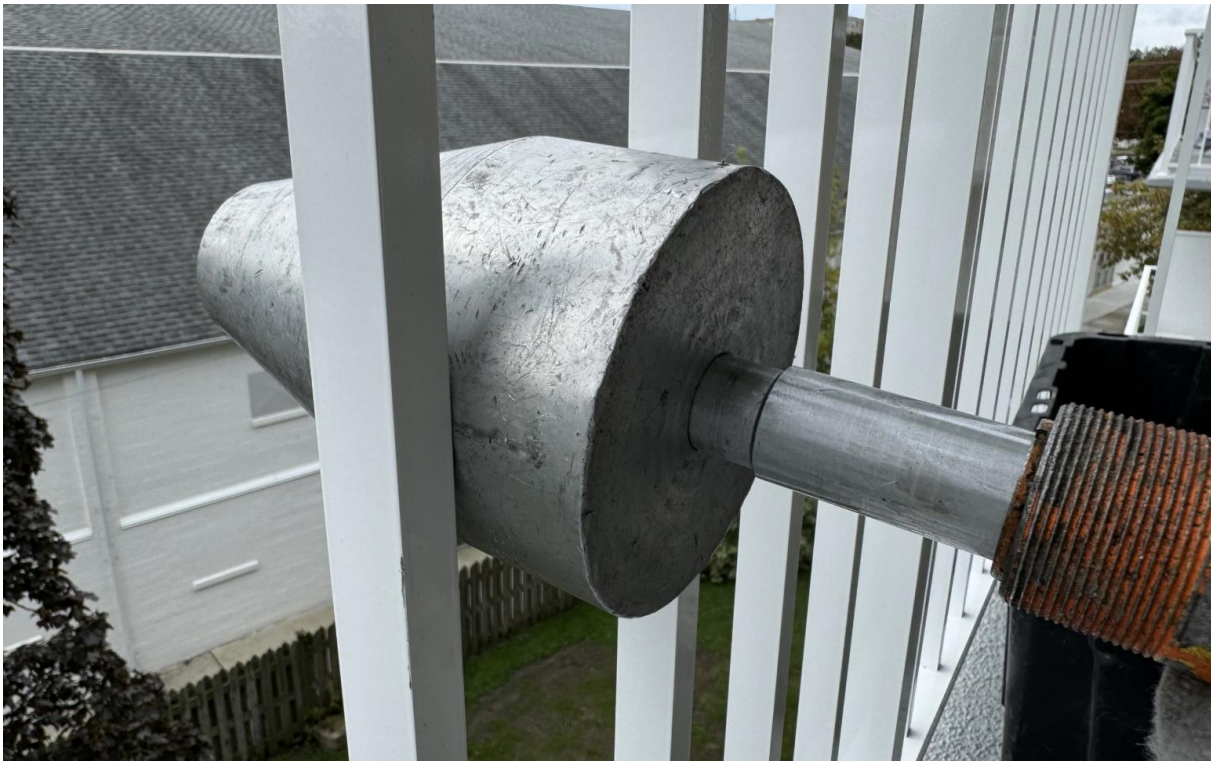
A horizontal outward load of 25 lbs. was applied at the mid-section of two pickets (Section M-K in Figure 1a) to check compliance with the opening criteria of Article 9.8.8.5 of OBC 2012.

Photograph 11: Checking picket gap by pushing a conical aluminum cone between two pickets
